Prepared for the
38th Aerospace Sciences Meeting and Exhibit
sponsored by the American Institute of Aeronautics and Astronautics
Reno, Nevada, January 10–13, 2000

RESTORATION OF THE HYPERSONIC TUNNEL FACILITY AT NASA GLENN RESEARCH CENTER, PLUM BROOK STATION

M.A. Woodling
National Aeronautics and Space Administration
Glenn Research Center
Cleveland, Ohio 44135

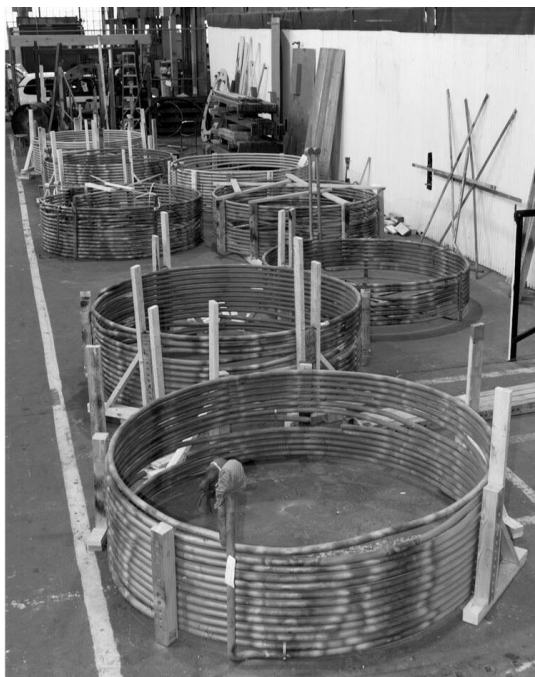
Consequently, each of the four coil sections contained roughly 7 brazed joints (sum total of 29 joints for the 4 coils). When pressure testing was performed on the bare coils, leaks were identified at some of the joints. Based on chemical analysis, it was determined that coil leakage during heater operations could lead to graphite susceptor block degradation⁴.

Figure 5.—HTF induction coils in wood fixtures during joint welding.
Note that each of the four major coil sections have been separated into smaller sections.

The induction coils typically must survive an 80 psig internal operating pressure (cooling water pressure) and a 1,200 psig maximum external pressure exerted by the flowing nitrogen gas. Based upon these conditions, the project team performed ASME B31.3 calculations to determine if the existing joints were structurally sufficient. Upon review of the results, a determination was made to replace every copper brazed joint with a copper welded joint. Since the chemical analysis had recommended that the total water vapor content within the heater be kept below 10 ppm, each joint was 100% x-ray inspected to ensure weld integrity. Figure 5 shows the wood fixtures used to support the coils during the joint welding procedures.

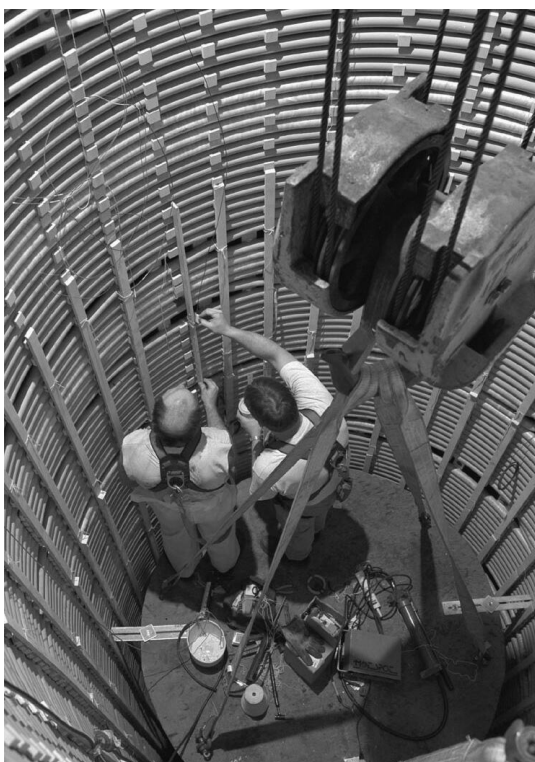
Figure 6.—Refurbished induction coils being installed within the
heater pressure vessel at the HTF site, Plum Brook Station, Sandusky, Ohio.

Figure 6 shows the refurbished coils being installed within the heater pressure vessel. Upon completion of the coil installation, a leak test with helium was performed again to ensure that no damage had occurred during shipping or installation. The de-ionized water inlet and outlet piping was then connected to the coils. As a final check, the entire system was successfully hydrotested again at 1.5 times the maximum operating pressure.

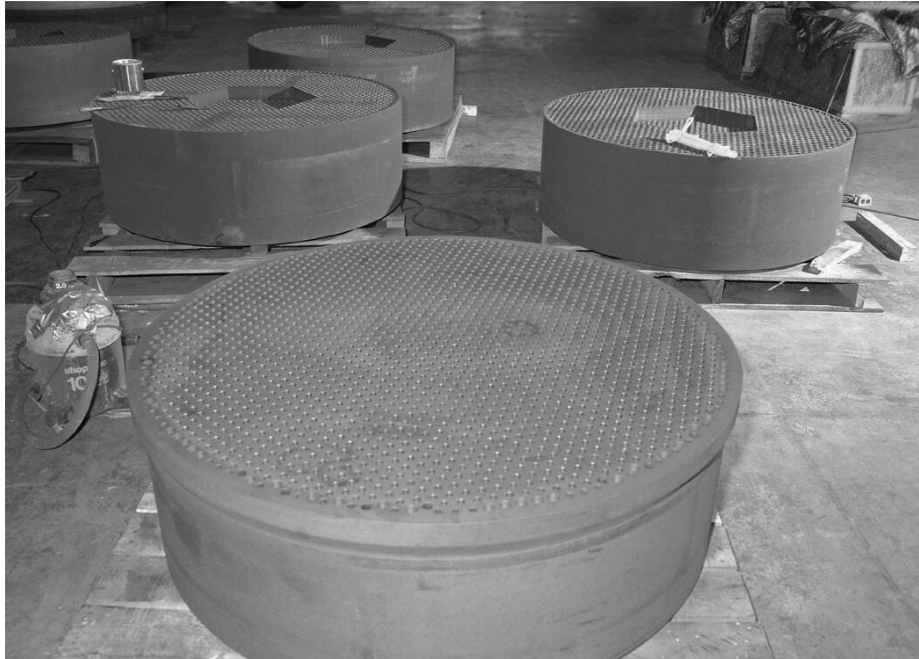
Following the RSV failure, the 15 susceptor blocks were removed from the induction heater. Inspection of the blocks indicated that the two upper-most susceptor blocks had cracks in the webbing between the holes and on the outer surface, and seven susceptor blocks

showed signs of significant perimeter erosion. Also, the graphite transition cone, located at the top of the susceptor core, sustained a deep crack all the way through the thickness of the cone. The six bottom-most blocks did not sustain any damage and were therefore considered to be reusable.

Figure 7.—Newly machined graphite susceptor blocks.

Figure 7 shows several of the newly machined susceptor blocks that were delivered to Plum Brook Station. As previously discussed, prior to installation, each block was wrapped with a 10-inch thick graphite blanket. These blankets were fabricated by stitching together multiple layers of graphite felt material. Figure 8 shows the susceptor blocks wrapped with the blankets. Prior to installation within the heater, the blankets were compressed with perimeter restraints attached to "release strings". Once a block was placed within the heater, the strings were pulled which released the restraints and allowed the blanket material to expand and fill the annular space between the perimeter of the block and the silicon tile wall.

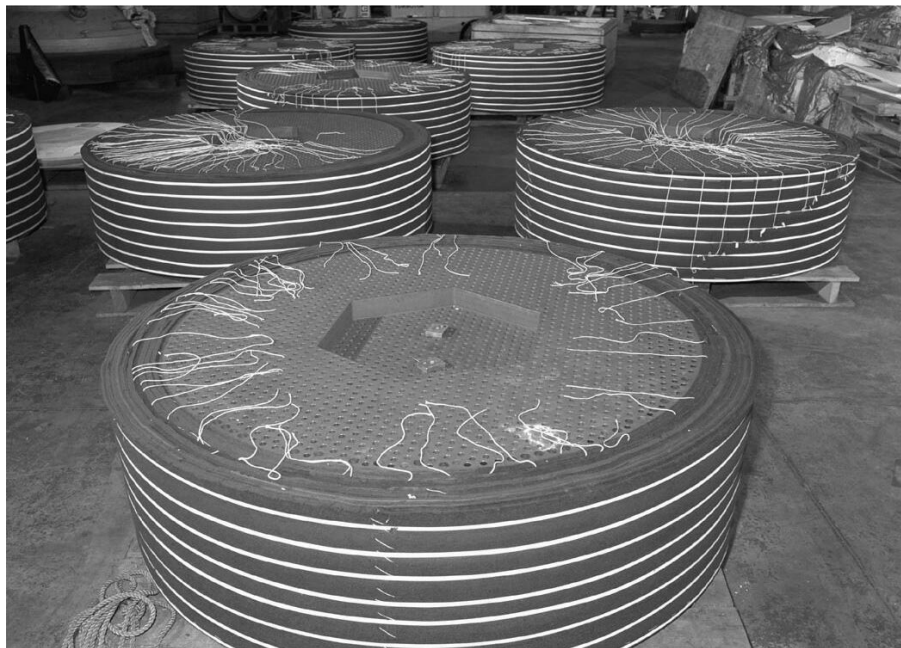
Figure 8.—Graphite susceptor blocks wrapped with graphite blankets.

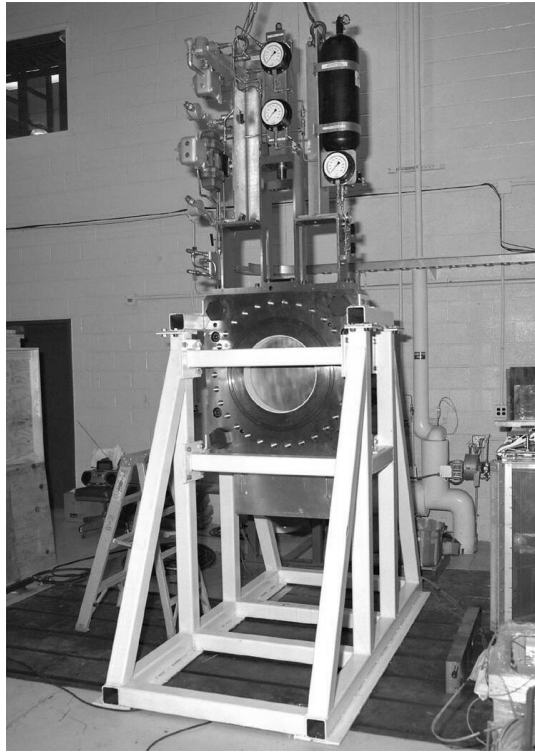
Figure 9.—Redesigned Radiation Shutter Valve (RSV) mounted in a stand for functional testing.

Upon completion of the structural verification testing, valve functional testing was initiated. The actuator package was attached to the valve body and the entire assembly was mounted in a customized stand (see Figure 9). A portable hydraulic unit was used to test and adjust all of the hydraulic functions. The blade travel distance was adjusted to ensure proper seating, and the stroke-time was set to 7 seconds.

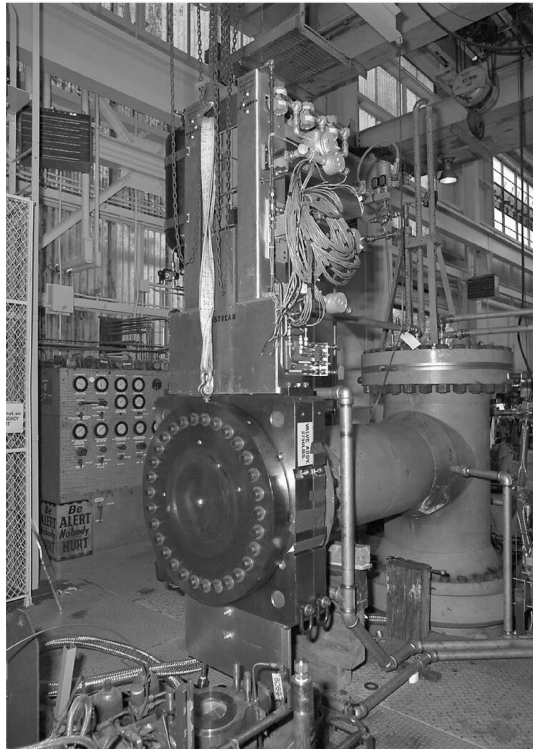
Figure 10.—Redesigned Radiation Shutter mounted on the Hot Tee at the HTF Site, Plum Brook Station.

Finally, a series of "stroke tests" were performed to check the repeatability of all measurements and to test the O-ring cavity seal gas integrity. By stroking the valve multiple times and then performing a pressure decay test on the O-ring seals, the design team was able to baseline a seal leakage rate to be used for valve operations. Following the stroke tests, the shutter blade was removed and sent to the NASA Glenn Inspection Department. The blade flatness values were base-lined for future comparison and the blade was reinstalled into the valve body. The assembled valve was then sent to Plum Brook for installation into the refurbished hot train (see Figure 10).

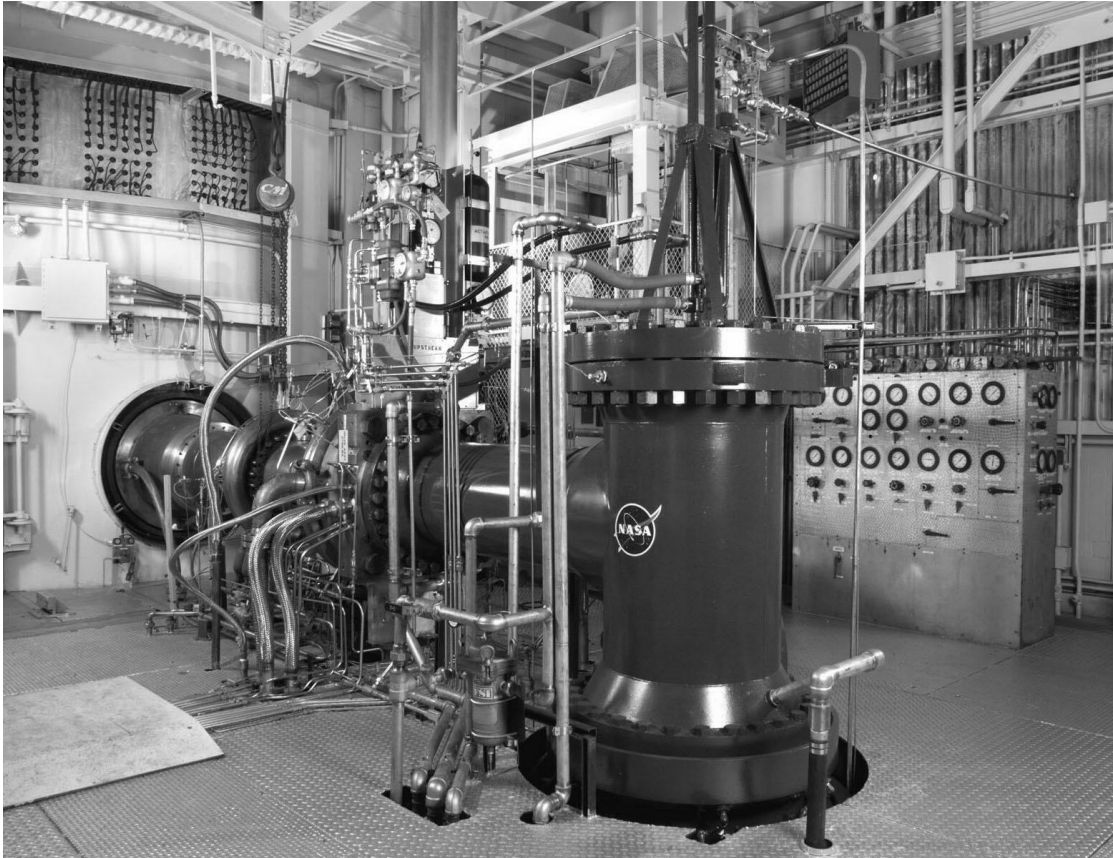
Figure 11.—HTF Hot Train assembly as of January 2000.
(View from behind the Hot Tee, looking towards the Test Cabin)
